# **HFDM4** Test Summary

S. Feher, G. Ambrosio, E. Barzi, B. Bordini, N. Andreev, R. Carcagno, M. J. Lamm, I. Novitski, D. Orris, Y. Pischalnikov, C. Sylvester, M. Tartaglia, J. C. Tompkins, R. Yamada, A.V. Zlobin

### 1. Introduction

HFDM04 is a mirror magnet made from newly wound and cured Nb3Sn cable (see construction report) which was made of RRP 0.7 mm strand. The magnet was completed, installed into the VMTF dewar and electrically checked out by February 18<sup>th</sup>, 2005. The VMTF dewar was filled with liquid helium on February 22<sup>th</sup>, 2004. This magnet went trough only one test cycle. The cold test has been completed on February 25<sup>th</sup>. On March 11<sup>th</sup>, 2005 the magnet was at room temperature and on March 14<sup>th</sup> it was removed from the dewar.

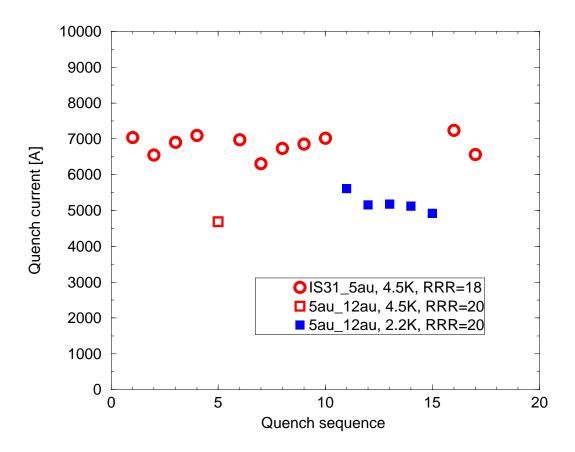
The first quench of the magnet was at relatively low value (7042A). It was about ~60% of the critical current value calculated on the basis of short sample critical current measurements of strands. The magnet exhibited practically no training. The fifth quench was even much lower than the rest of the quenches. Then the magnet was cooled down to 2.2K to be exposed to higher Lorentz forces. Instead of increasing the quench current we observed quenches at ~5000 A current range. Increasing the temperature back to 4.5K the magnet quench current went back to the same current range we observed prior of quenching it at 2.2K. All the quench locations but one at 4.5K were at the inner coil midplane block. The 2.2K quenches were in the inner coil middle block region. Unfortunately it was not possible to further localize the quenches since there were not enough V-taps attached to the coils. Low quench current values and erratic behavior indicates that the magnet is likely to be limited by conductor instabilities. The quench summary is shown in Fig 1. and the details of quenches (and other quench or trip events) are described in Table 1.

Fig. 1. Quench history of HFDM04 is shown.

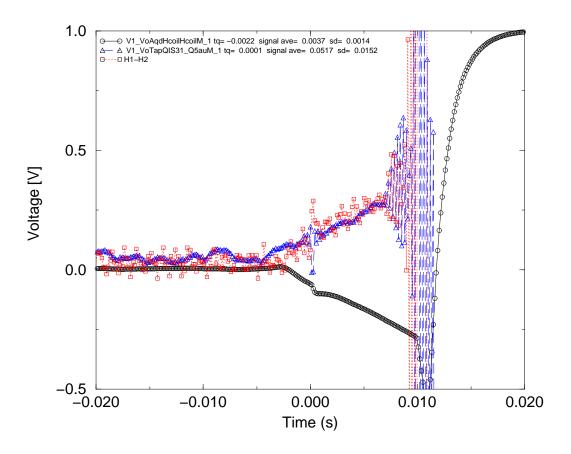
Fig 2. Voltage traces for quench number 1. Three voltage segments are plotted: two half coil bucked signals and QIS31\_Q5au where the quench has started.

From Fig.2 to Fig. 4. one can notice that the voltage rises of the first and the second quenches relative to the third one are quite different. We analyzed each quenches and determined the rate of the resistance rise for the first few milliseconds. The resistance rise can be converted to quench propagation velocity by making the assumption that the cable resistance (1.7 m $\Omega$ /m) and the RRR (20) is known. Since the average field is 2-3 T the magneto-resistance was neglected. The obtained quench velocity as a function of the magnet current is plotted in Fig. 5. Some of the voltage rises were quite high so we obtained unrealistic quench velocities. However, if we make the assumption that these quenches occurred simultaneously at multiple locations we have to divide the quench velocities with the number of locations. The newly obtained (normalized to one turn or location) quench velocities fall into the expected range of velocities as a function of the quench current. We can also conclude that the relatively low quench velocity value (< 20 m/s) is consistent with a quench current being far from the critical current limit.

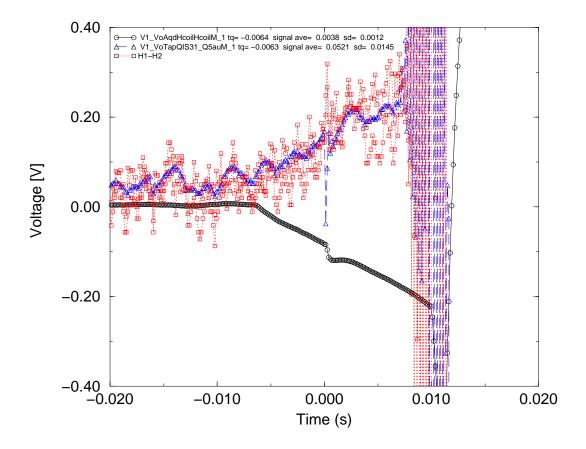
Fig 3. Voltage traces for quench number 2. Three voltage segments are plotted: two half coil bucked signals and QIS31\_Q5au where the quench has started.

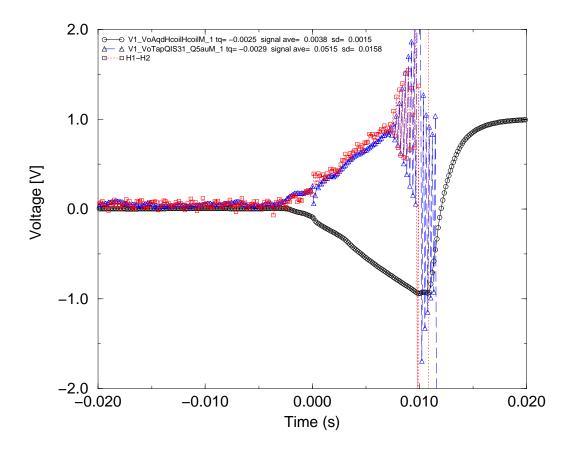
Fig 4. Voltage traces for quench number 3. Three voltage segments are plotted: two half coil bucked signals and QIS31\_Q5au where the quench has started.

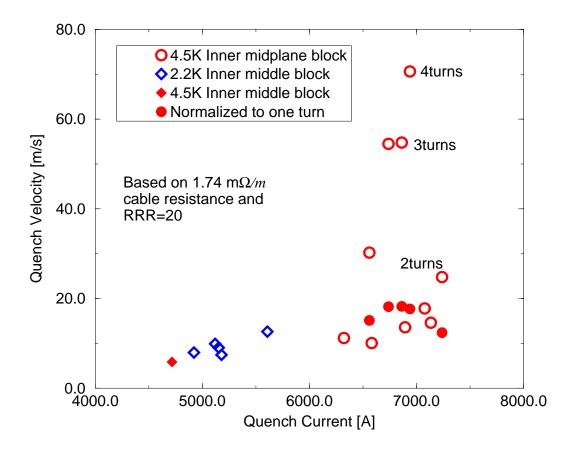
Fig 5. Quench velocities as a function of quench current. Some of the quench velocities were unrealistically high probably due to the fact that we were estimating them by resistance rise and there were multiple quenches at the same block we recorded the voltage. Dividing the quench velocity values with an appropriate integer number (number of locations or turns) the newly obtained normalized values fall within the expected range.

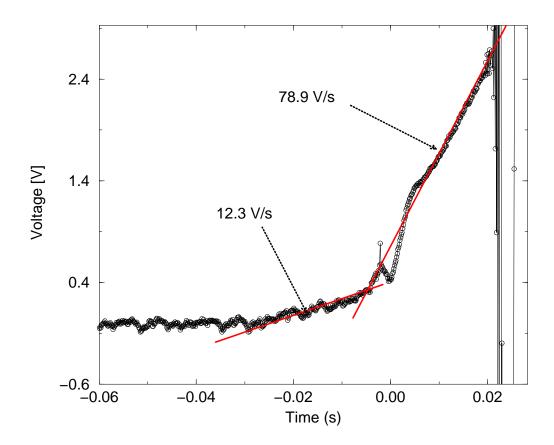
In Fig. 6. quench #11 was plotted. It is quite clear from the voltage rise and from the calculated quench velocities of the two different phase of the propagation that about -3ms prior the quench was detected the quench propagation speeds up. It is consistent with a hypothesis that all the seven turns of the inner coil middle block have quenched caused a faster voltage rise.

Fig. 6. Voltage rise of the 11<sup>th</sup> quench is plotted. Multiple turn quench was observed at -3ms time stamp.

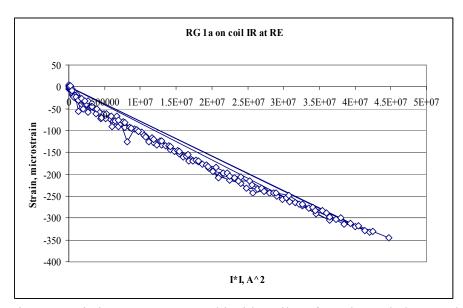
Fig. 7. Resistive gauge mounted inside coil surface showed clear strain dependence as a function of the Lorentz force.

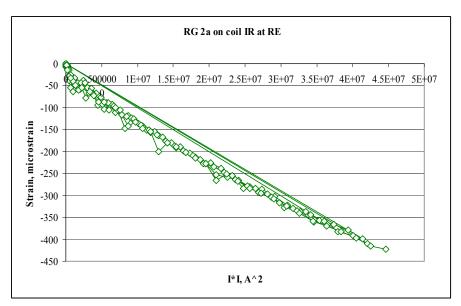
Fig. 8. Resistive gauge mounted inside coil surface showed clear strain dependence as a function of the Lorentz force.

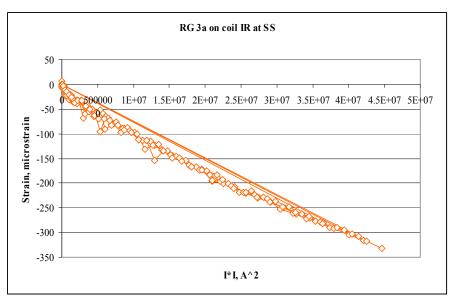
Fig. 9. Resistive gauge mounted inside coil surface showed clear strain dependence as a function of the Lorentz force.

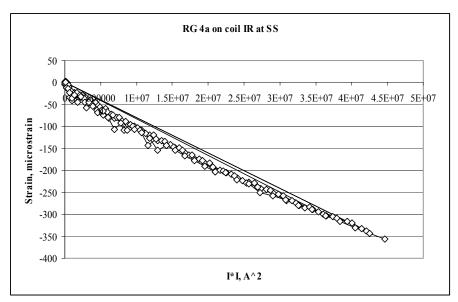
Fig. 10. Resistive gauge mounted inside coil surface showed clear strain dependence as a function of the Lorentz force.

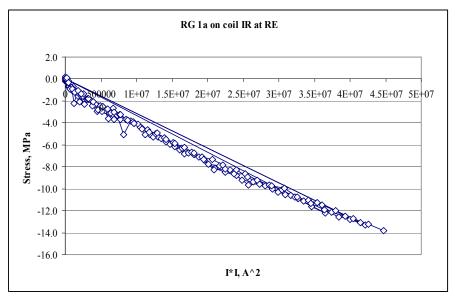
Fig. 11. Resistive gauge mounted inside coil surface showed clear stress dependence as a function of the Lorentz force.

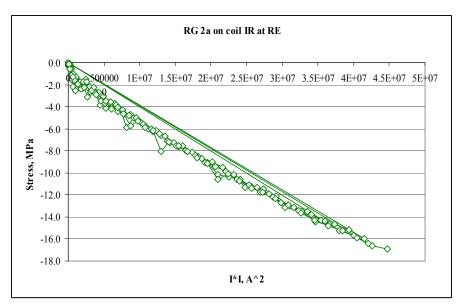
Fig. 12. Resistive gauge mounted inside coil surface showed clear stress dependence as a function of the Lorentz force.

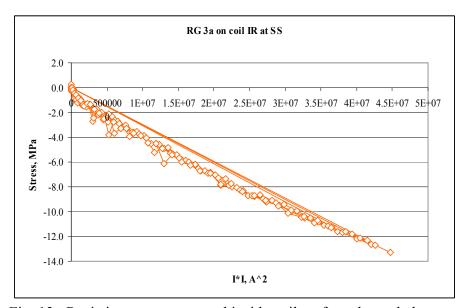
Fig. 13. Resistive gauge mounted inside coil surface showed clear stress dependence as a function of the Lorentz force.

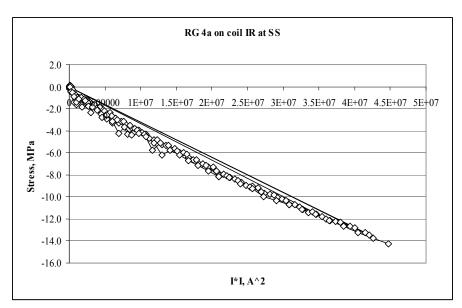
Fig. 14. Resistive gauge mounted inside coil surface showed clear stress dependence as a function of the Lorentz force.

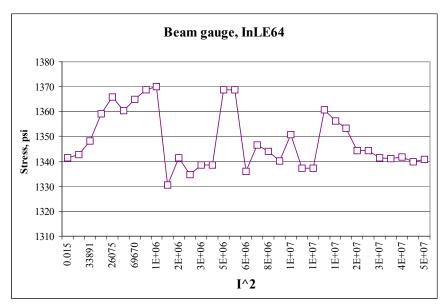
Fig. 15. Resistive beam gauge mounted at the surface of the mid-plane close to the splice region showed no clear sign of loading.

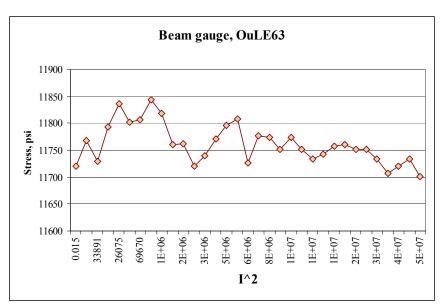
Fig. 16. Resistive beam gauge mounted at the surface of the mid-plane close to the splice region showed no clear sign of loading.

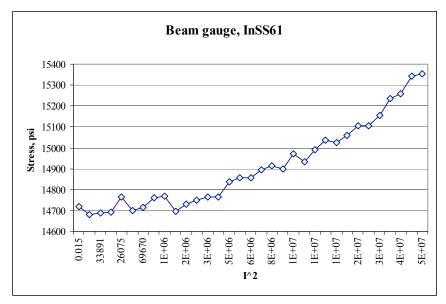
Fig. 17. Resistive beam gauge mounted at the surface of the mid-plane in the body region of the coil showed a clear change of the load as a function of the Lorentz force.

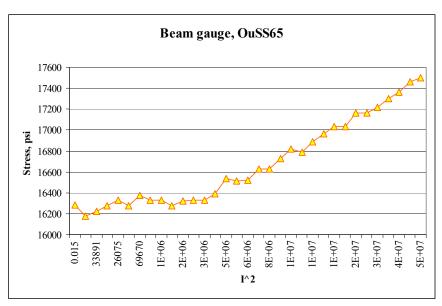
Fig. 18. Resistive beam gauge mounted at the surface of the mid-plane in the body region of the coil showed a clear change of the load as a function of the Lorentz force.

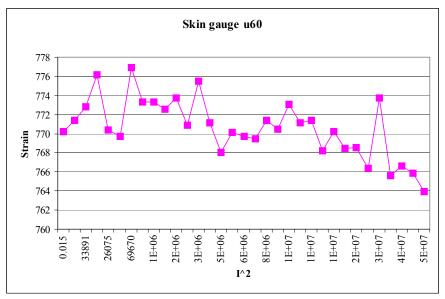
Fig. 19. Resistive skin gauge showed no clear change of the load as a function of the Lorentz force.

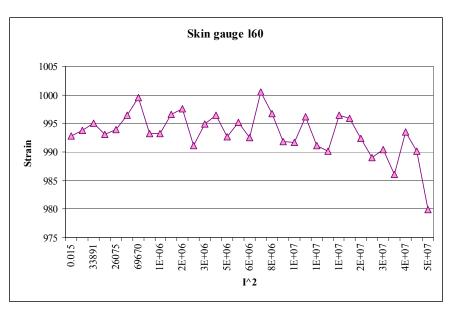
Fig. 20. Resistive skin gauge showed no clear change of the load as a function of the Lorentz force.

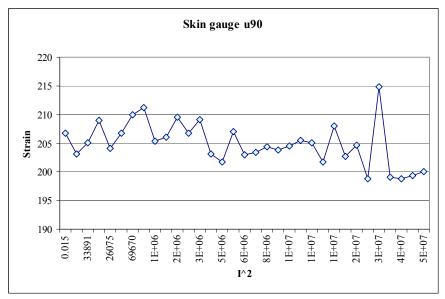
Fig. 21. Resistive skin gauge showed no clear change of the load as a function of the Lorentz force.

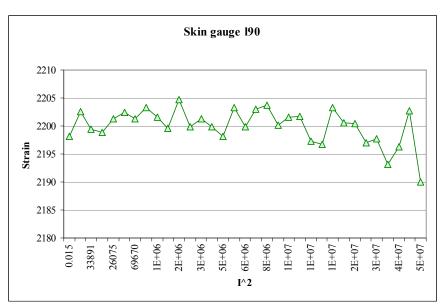
Fig. 22. Resistive skin gauge showed no clear change of the load as a function of the Lorentz force.

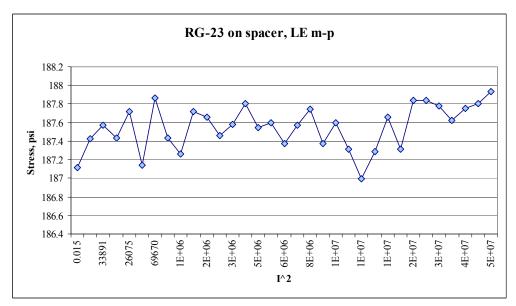
Fig. 23. Resistive gauge mounted onto the surface of the spacer showed no clear change of the load as a function of the Lorentz force.

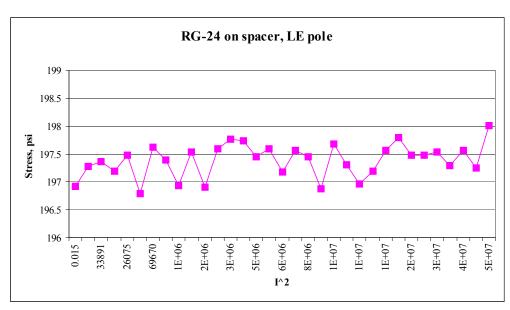
Fig. 24. Resistive gauge mounted onto the surface of the spacer showed no clear change of the load as a function of the Lorentz force.

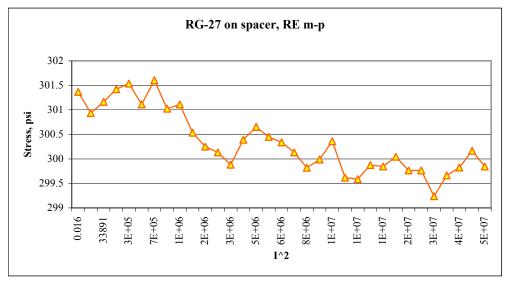
Fig. 25. Resistive gauge mounted onto the surface of the spacer showed no clear change of the load as a function of the Lorentz force.

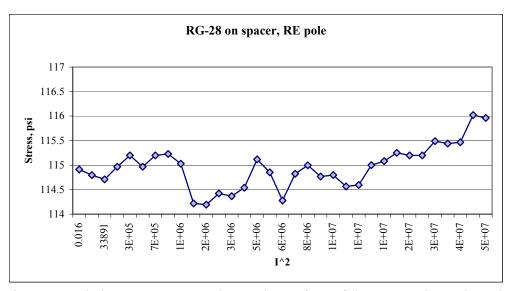
Fig. 26. Resistive gauge mounted onto the surface of the spacer showed no clear change of the load as a function of the Lorentz force.
